**APPLICABILITY OF THE KRYPTONATE®
TECHNIQUE TO THE PREDICTION
OF USEFUL FATIGUE LIFE**

Panametrics, Inc.

TECHNICAL REPORT AFFDL-TR-69-55

JANUARY 1970

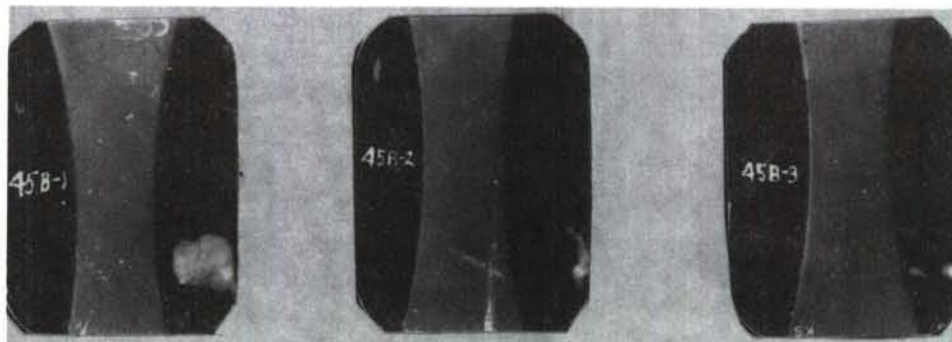
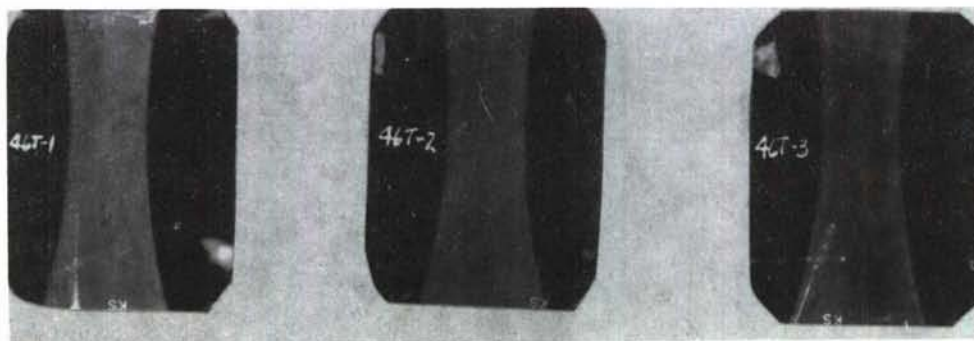
This ambiguity was further investigated by the radiographs obtained from Set 4 which was processed in the same manner as Set 3 prior to testing. For this set no striations were detectable after cycling nor were any other features that could be associated with fatigue damage. Some structure was observed as on surface 46-T (see Fig. 6) but a more frequently encountered radiographic pattern is shown by surface 45-B, also seen in Fig. 6. Both surfaces had been subjected to 75% of their nominal fatigue life.

Figure 6. Selected Autoradiographs of Set 4 Cycled to 75% of Expected Failure

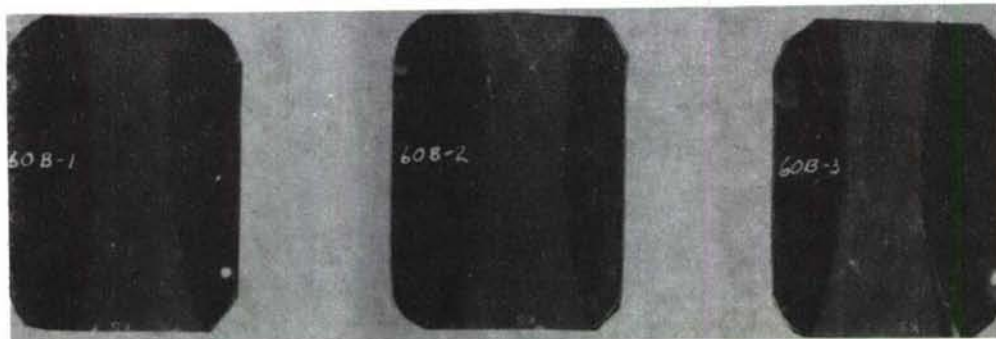
Figure 7. Selected Autoradiographs of Set 5

All sets discussed thus far were tested on the same test machine at the same stress levels. Under these conditions crack propagation followed so closely upon initiation that no partially failed specimens were obtained. To ascertain the effects, if any, of testing conditions, Set 5 was cycled in fully reversed bending at a high stress level. One partially failed specimen was obtained which was cycled to 90% of nominal failure. This is shown by surface 62-T in Fig. 7 wherein a crack, visible to the eye, is indicated by an arrow. The radiograph taken after HCl etch shows a pattern of dark spots. But even in this situation where it is known that failure is imminent, the radiographic pattern cannot be differentiated from that of surface 60-B which has been cycled to only 60% of nominal failure, i. e., the crack is not detectable by the techniques used. If, however, the Kryptonate preparation procedure were to be applied to a partially failed specimen, the crack would become evident in the same manner as the scratch shown in Fig. 3.
